# Manhole Inspection Summary

Manhole # S43KK\_047MH

Insp Date: **8/13/08 9:08 AM**

**Location** Address: **RUTLAND**

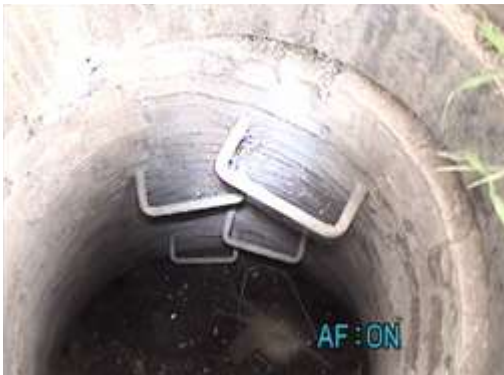
Defect 1

**Frame** Offset: **1** (in.) Condition: ☐ Sound ☐ Cracked ☒ **Leaks**

Frame leaks

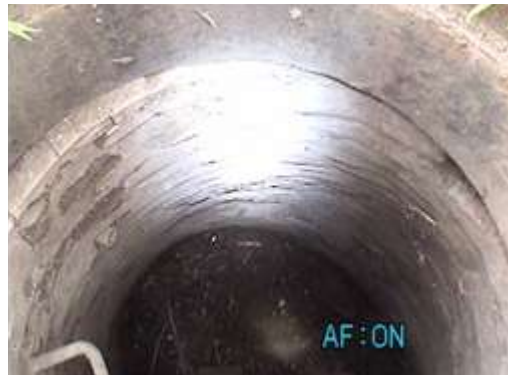
Defect 2

Infiltration: ☐ None ☒ **Joint** ☐ Cracks ☒ **Mortar** ☐ Roots ☐ Wall

Infiltration

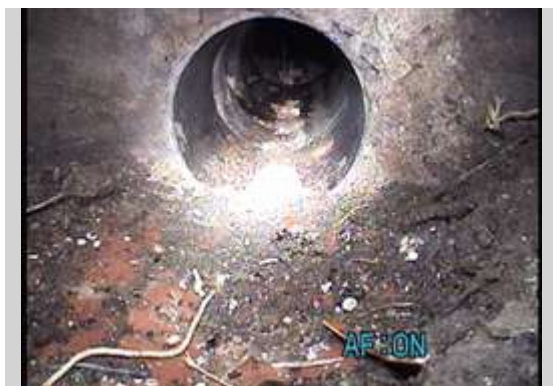
12 O'Clock Outflow

8 in. Circular Gravity Sewer  
Pipe Out @ 12 O'Clock

Infiltration: **None** Pipe Seal Cond: **Sound**
